Lower Snitz Creek Restoration Project: Hershey Property

North Cornwall Township, Lebanon County, Pennsylvania

Doc Fritchey Chapter of Trout Unlimited

Clear Creeks Consulting

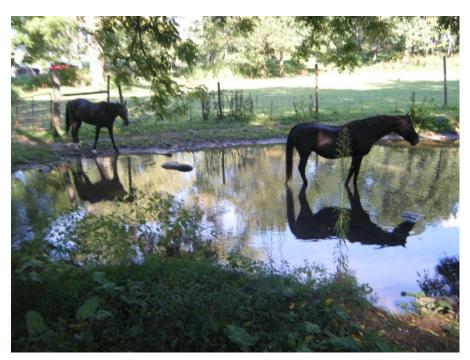
Fig. 1 – Horses in Snitz Creek, immediately upstream from the Hershey's driveway.

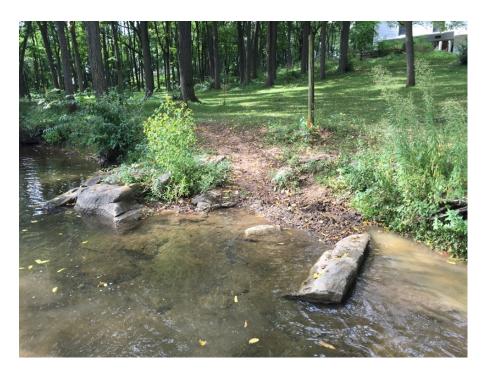
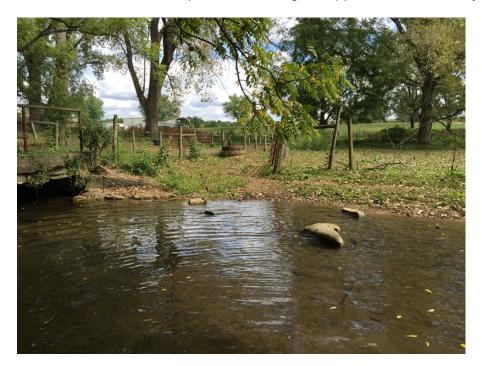
Horse trails traverse the channel at numerous locations. As a result of the unlimited livestock access, streambanks have been trampled leaving a major portion of the project area wide and shallow.

Figs. 2 and 3 – Horse trails and trampled banks along the upper reach of the Project Area

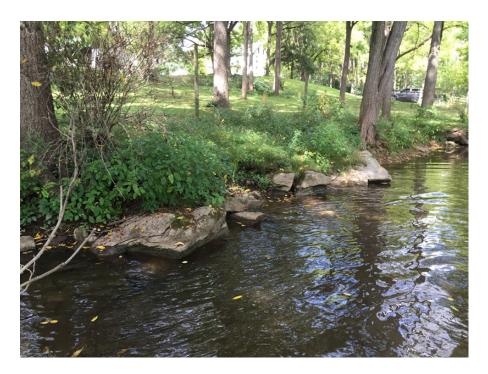
Fig. 4 – Exposed bedrock along stable banks

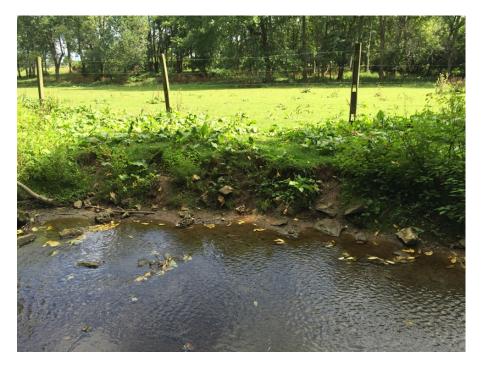
Fig. 5 – Streambank erosion is evident along upper reach. Note lack of woody vegetation and poor ground cover.

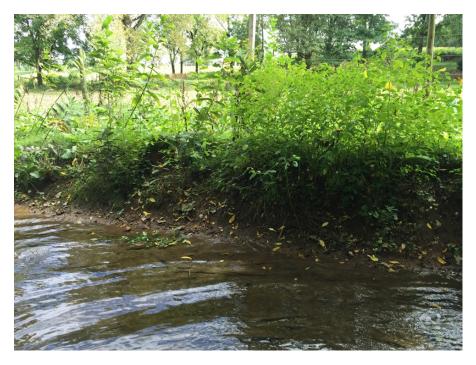
Fig. 6 – Streambank erosion is evident along upper reach. Note lack of woody vegetation and poor ground cover.

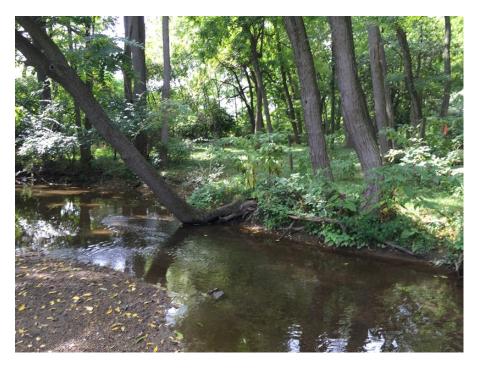
With the exception of areas protected by bedrock outcrops, the project area exhibits bank erosion along much of its length. Although the riparian area has some mature trees, a large portion of the streambank trees are severely undercut with leaning or in danger of falling into the channel. Invasive plant species including Oriental Bittersweet, Tartarian Honeysuckle, Tree of Heaven and Multiflora Rose are preventing native plants from thriving.

Fig. 7 – Undercut and leaning trees

- 1. Stabilize streambanks to reduce erosion.
- 2. Reconstruct streambanks to protect existing streambank trees that are in jeopardy of falling into and across the stream.
- 3. Narrow the bankfull and baseflow channel to increase sediment transport, stream depth and water velocity and reduce sunlight impinging on the stream.
- 4. Install in-stream habitat structures that will provide cover and resting places for trout.
- 5. Provide long-term stabilization with native trees and shrubs throughout.
- 6. Install fencing along unfenced pasture areas and repair existing fencing to keep horses and other livestock out of the stream.
- 7. Install a new stabilized livestock crossing.
- 8. Remove invasive plant species.

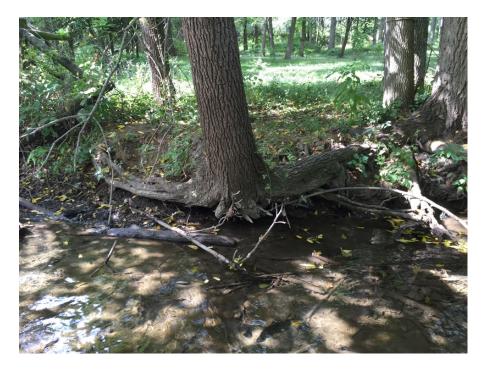
Fig. 8 – Undercut and leaning trees

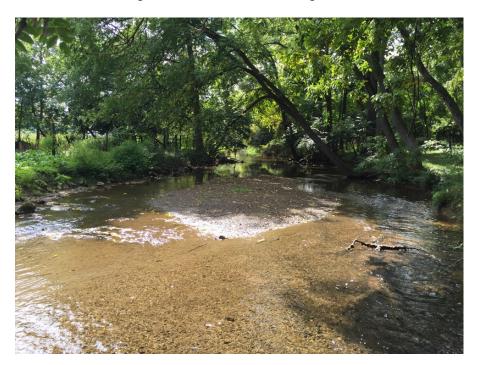
Fig. 9 – Large mid-channel bar along upper reach
